EVALUATION OF REDESIGNED XW18 MEMBRANE
AND ACCESSORIES

TECHNICAL REPORT S-73-3

Conducted by U. S. Army Engineer Waterways Experiment Station
Soils and Pavements Laboratory
Vicksburg, Mississippi

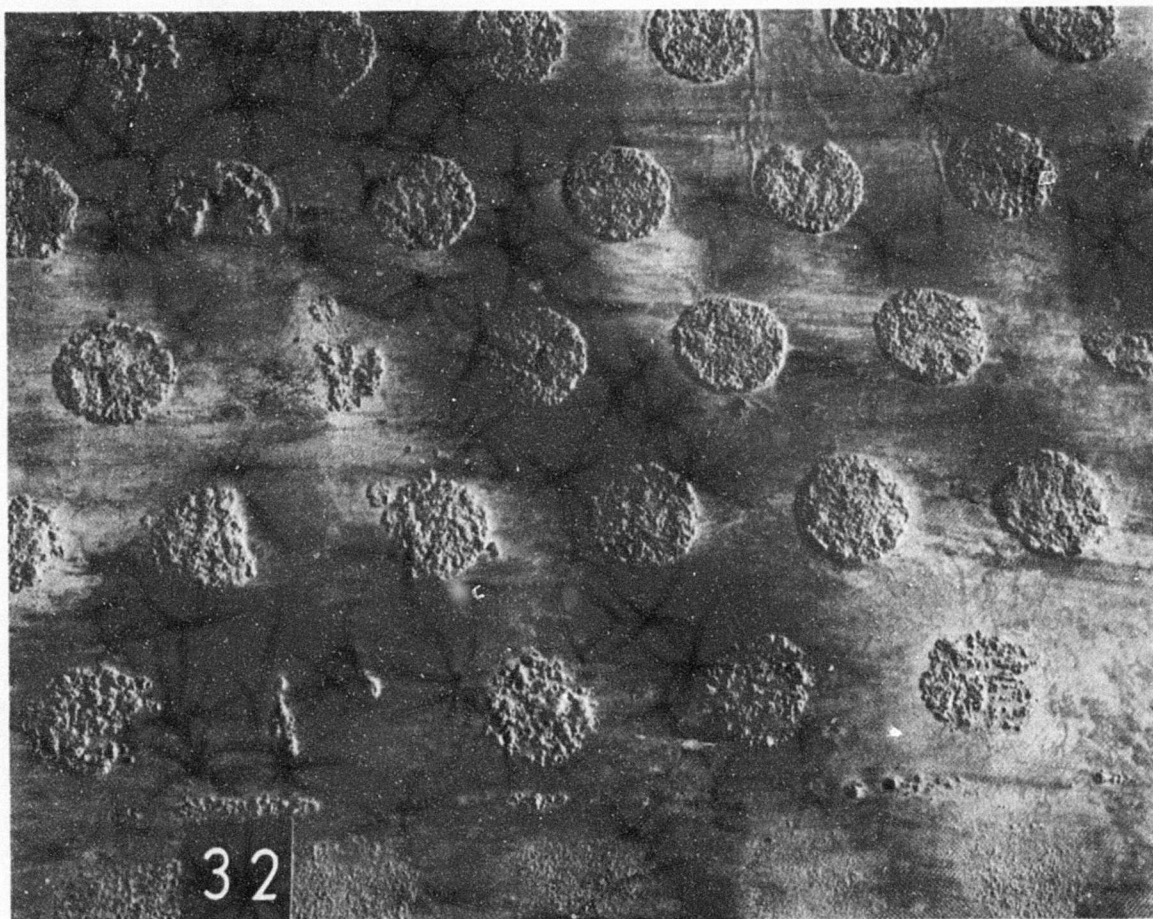
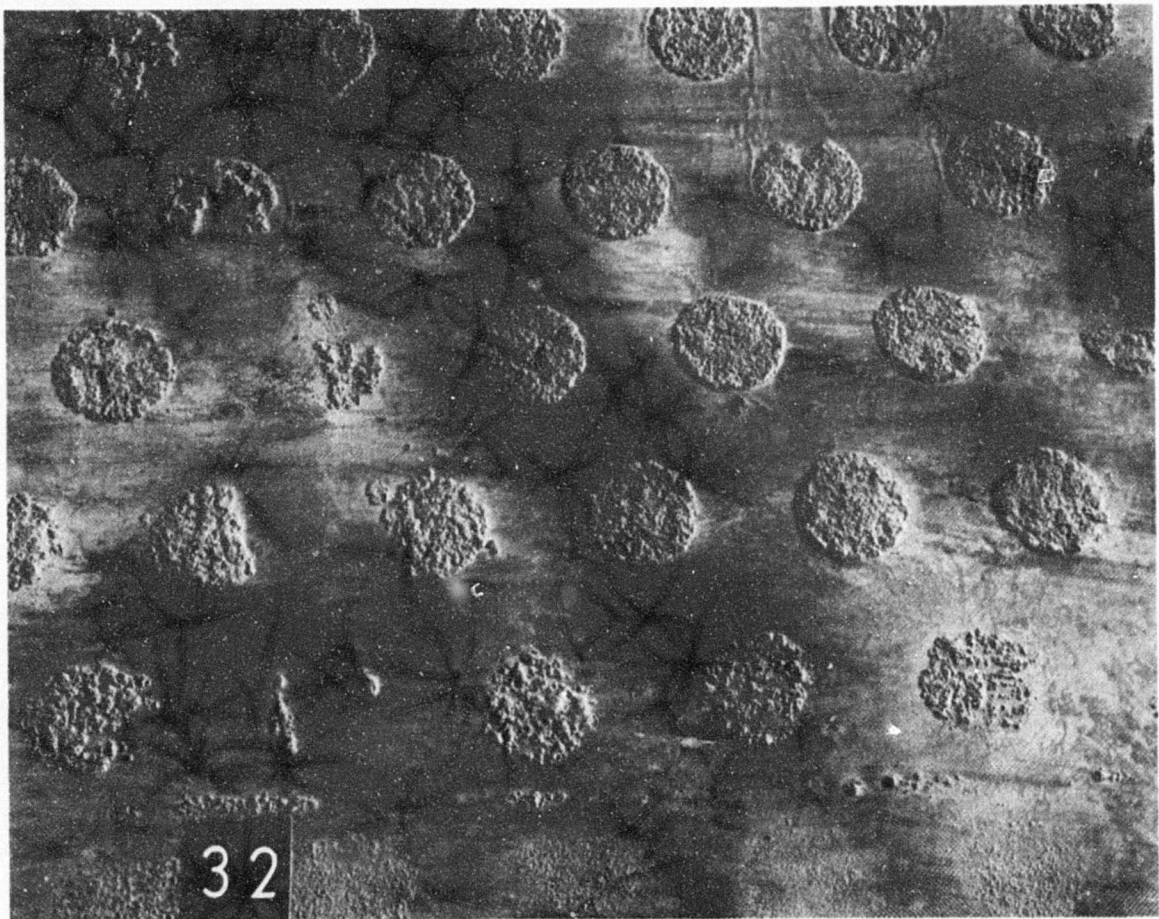
33. An examination of the surface after the skid tests revealed that approximately 36 percent of the nonskid compound was removed after the dry skids (photo 12) and approximately 23 percent was removed after the wet skids (photo 13). Cross sections of the surface made at 6-ft intervals and a center-line profile of a rut caused by a typical skid are shown in plate 6.

Photo 13. Nonskid removed after wet skid on XW18 membrane section 2

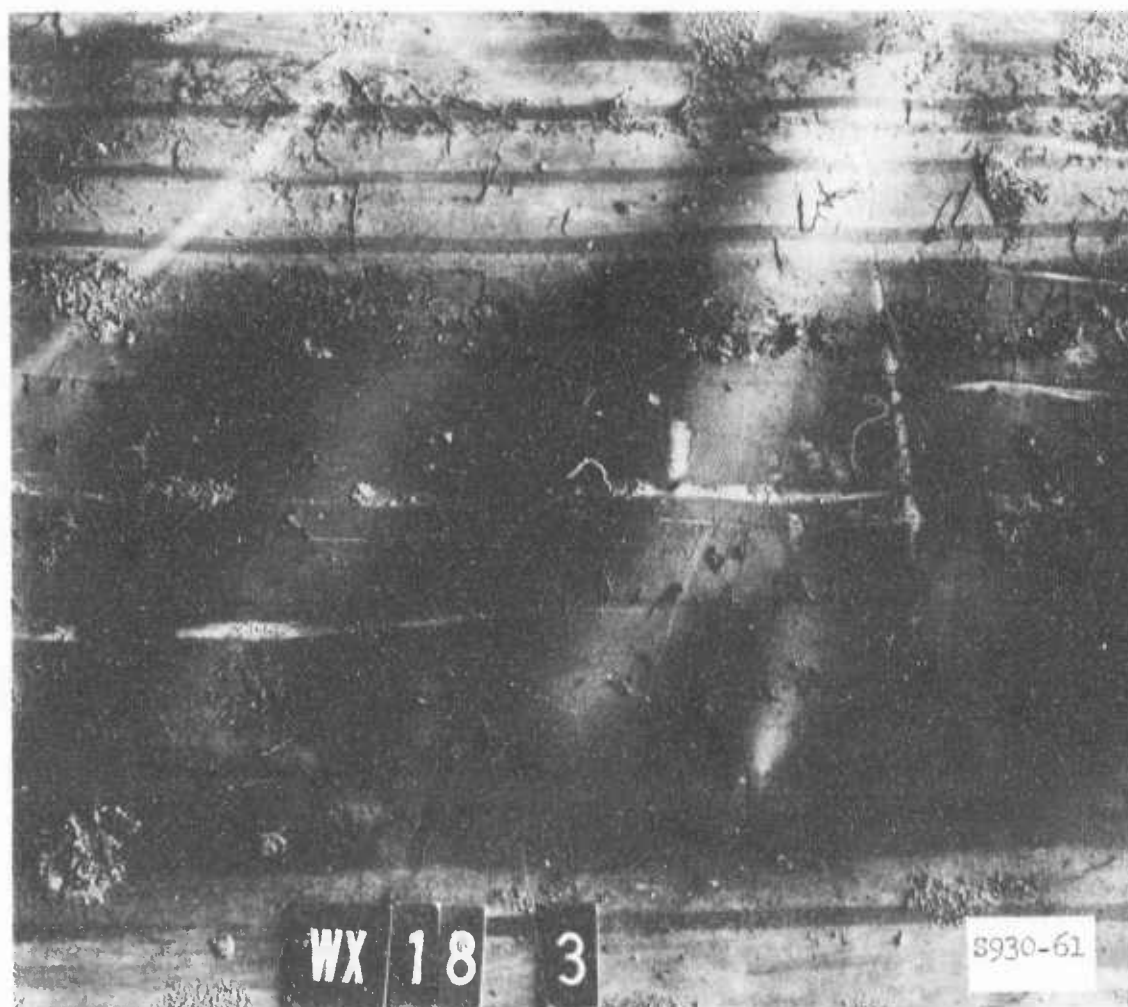
30. An examination of the surface after the skid tests revealed that approximately 97 percent of the nonskid compound was removed after the dry skids (photo 6) and approximately 59 percent was removed after the wet skids (photo 7). Cross sections of the surface made at 6-ft intervals and a center-line profile of a rut caused by a typical skid are shown in plate 5.

Photo 6. Removal of nonskid on XW18 membrane section 1
after one dry skid

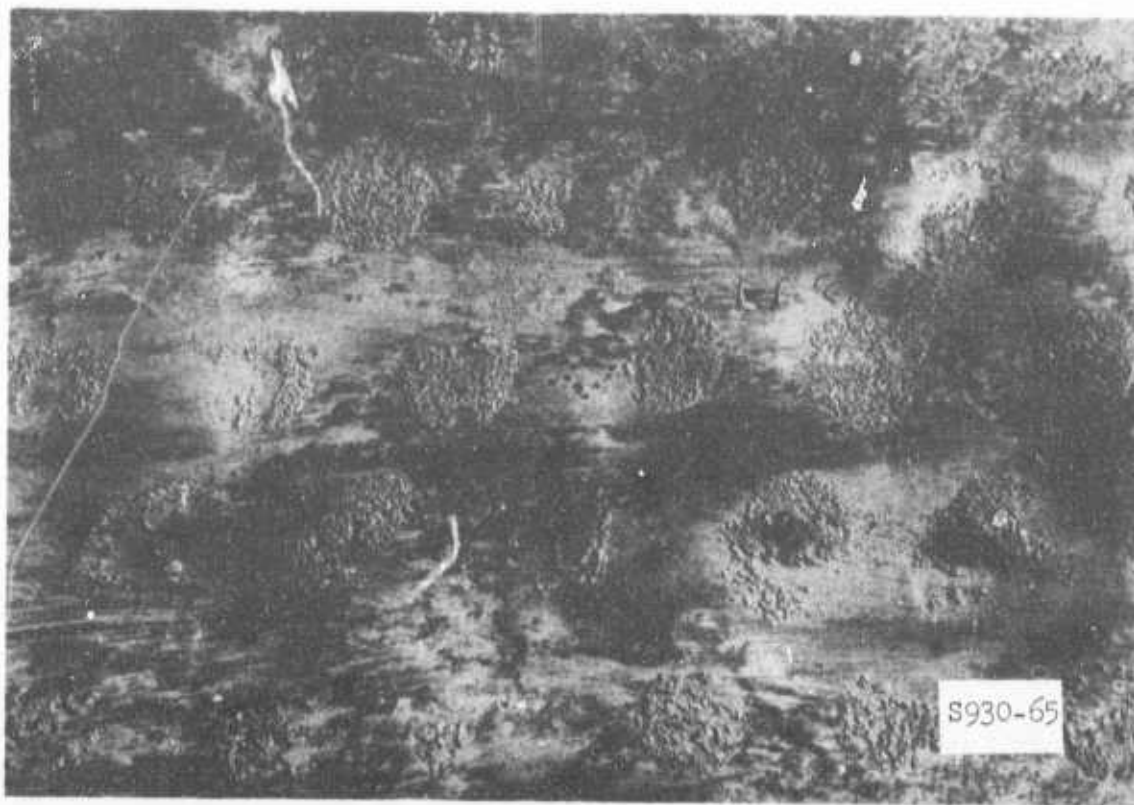
Photo 7. Removal of nonskid on XW18 membrane section 1
after one wet skid

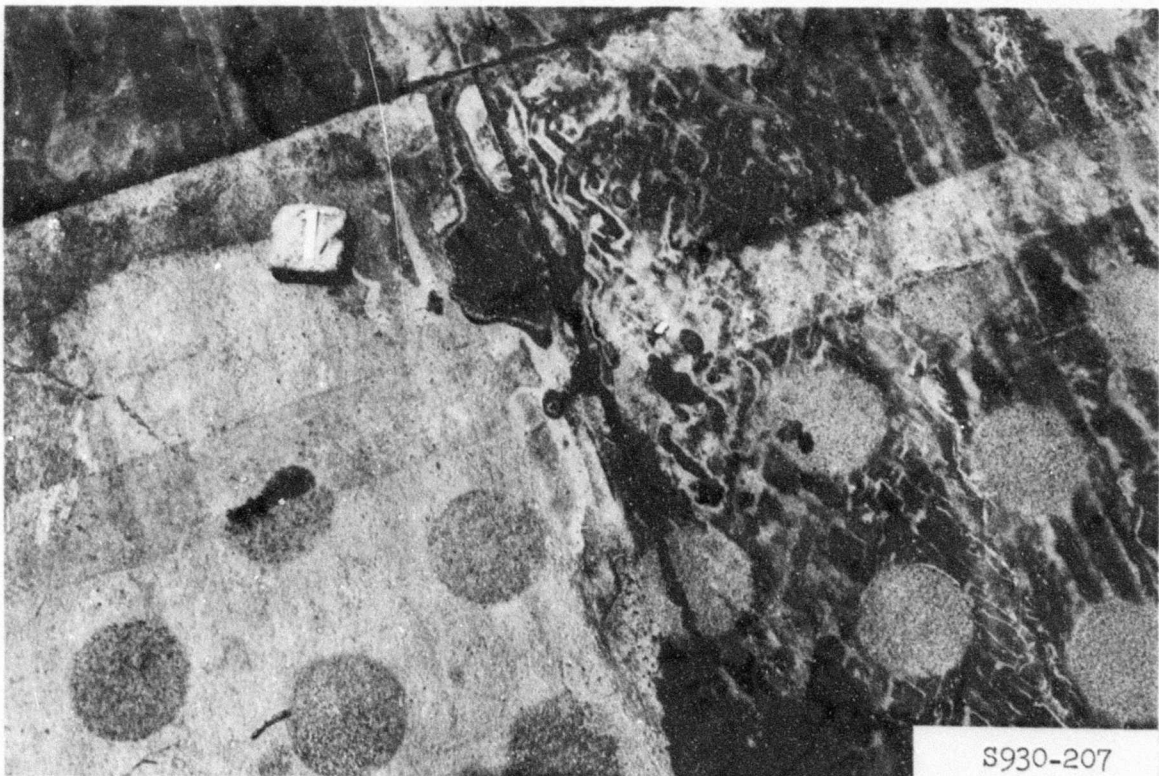
Photo 44. Soil pumping through 2-ft-wide adhesive construction joint at overlap of factory fabricated joint after 2 coverages of test wheel on test section 1

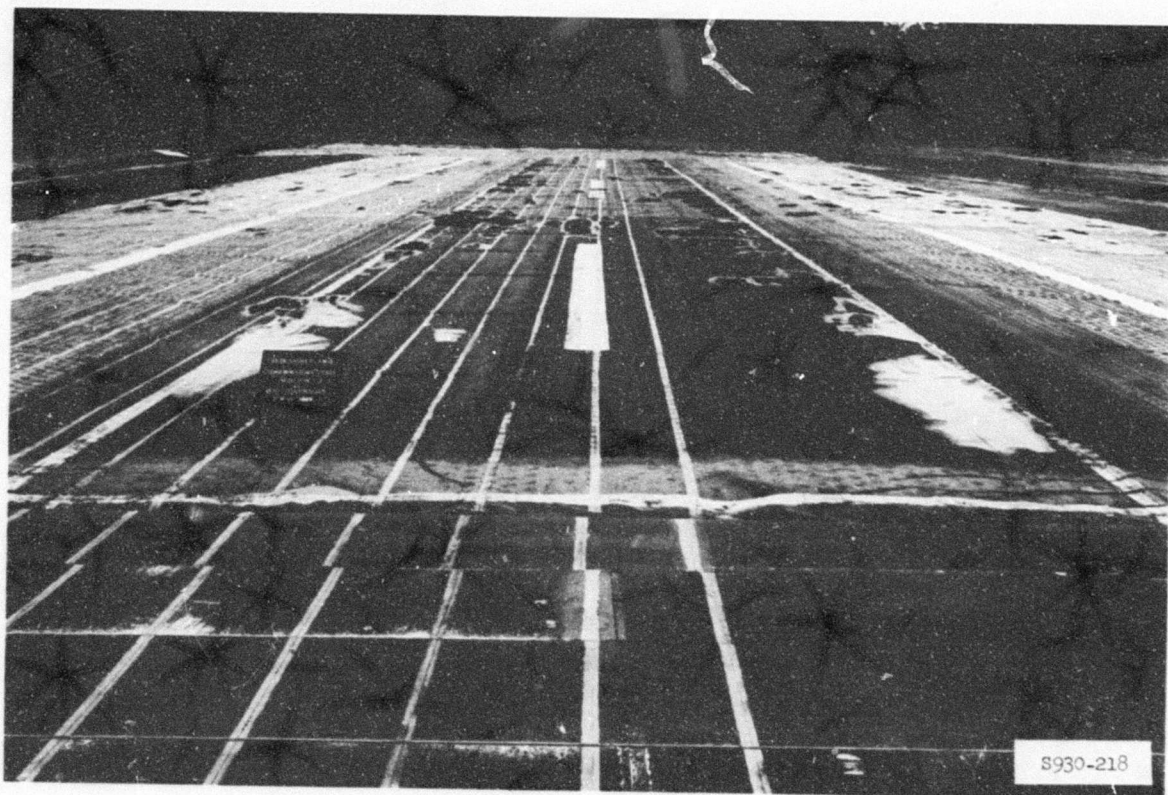
Photo 49. General condition of test section 1 after 200 coverages

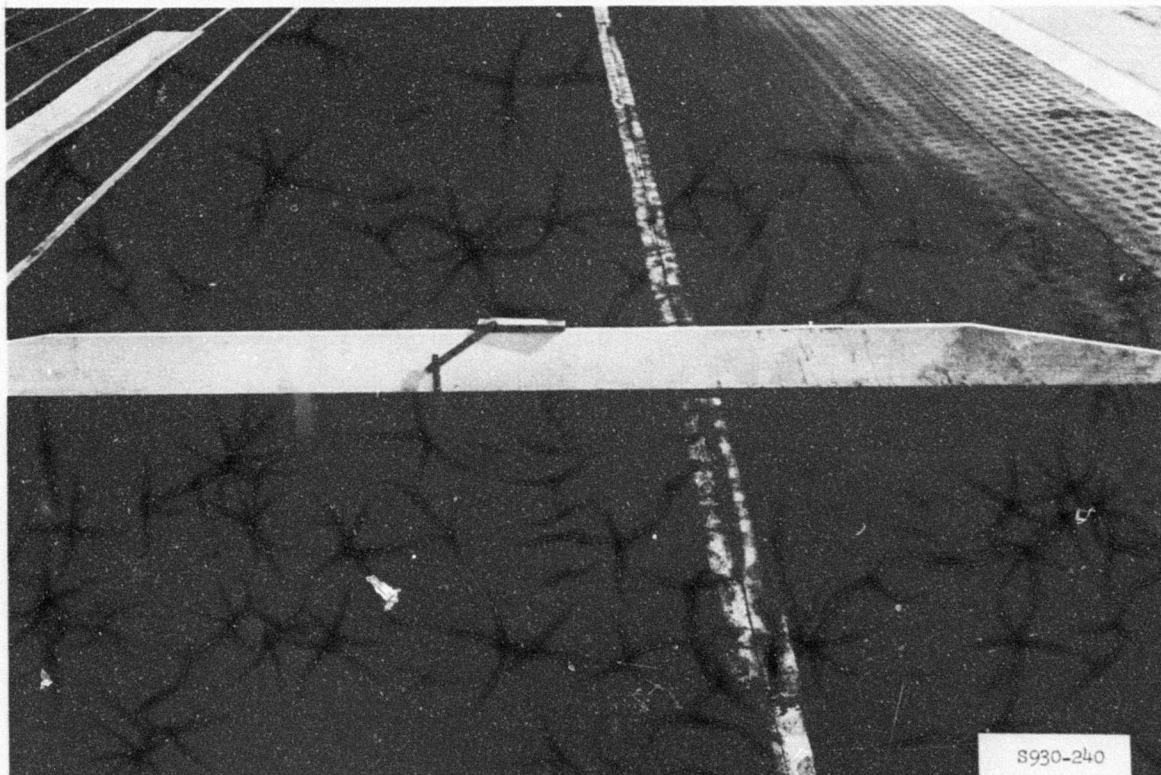
Photo 51. Rutting of subgrade of test section 1, sta 0+75, after 400 coverages

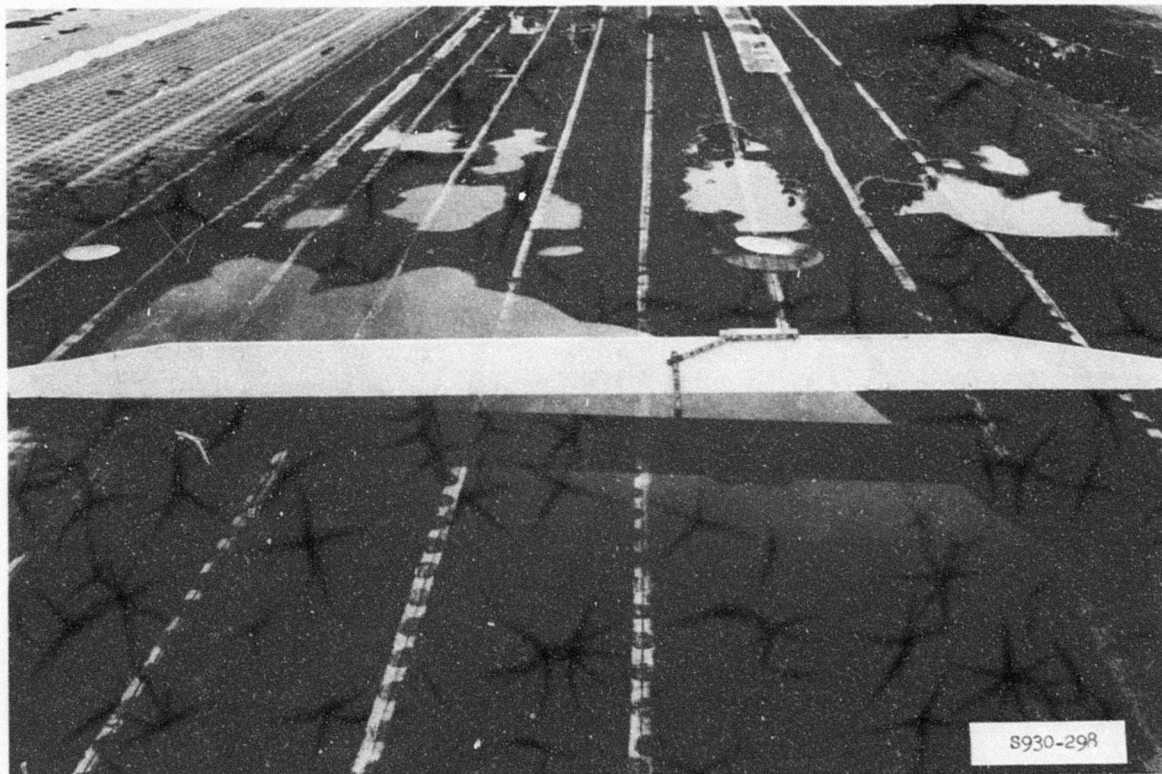
Photo 55. Rutting of subgrade of test section 1, sta 1+05, after 538 coverages

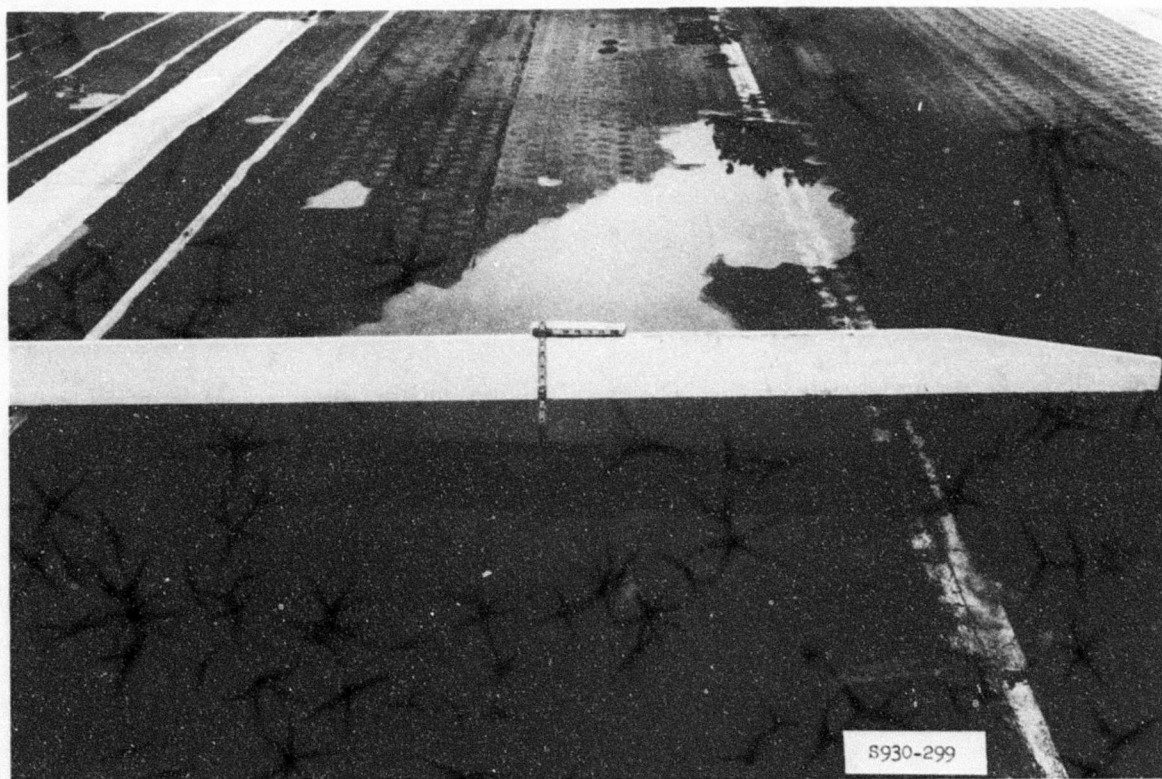
Photo 56. Rutting of east edge of subgrade of test section 1, sta 0+75, after 538 coverages

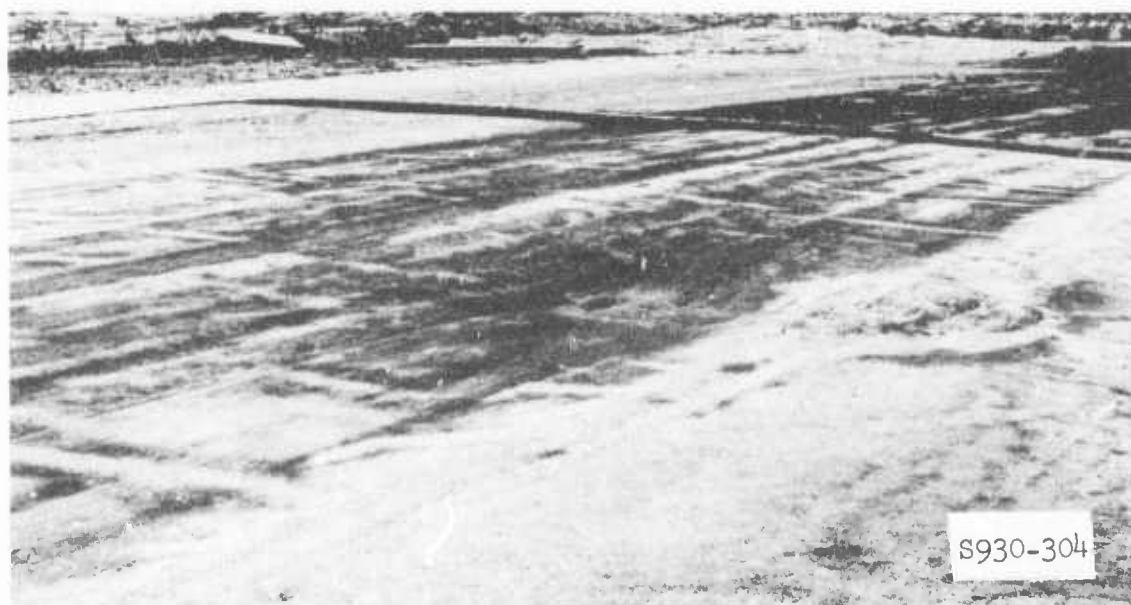
Photo 58. Sheet 2 of test section 1 cut along sides and folded back for repair of subgrade (538 coverages); note depressed area at center

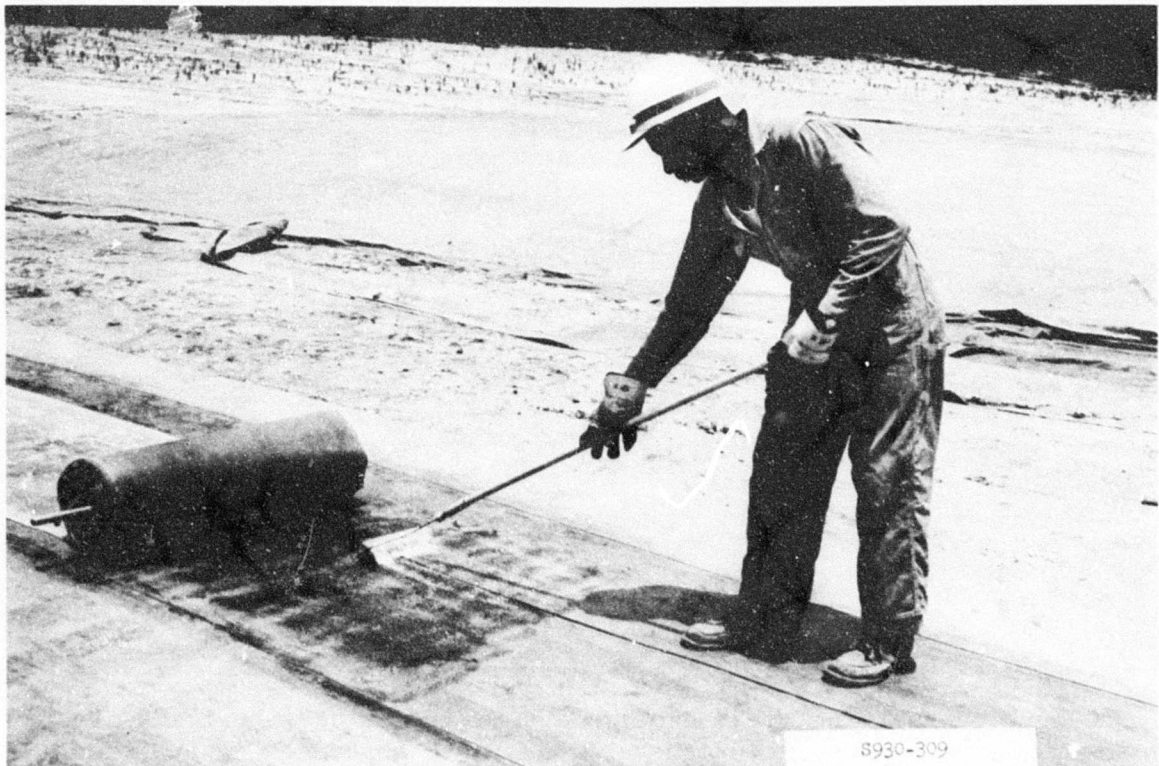
Photo 60. Applying 3-ft-wide strip of membrane to cut made on sheet 2 of test section 1 for subgrade repair

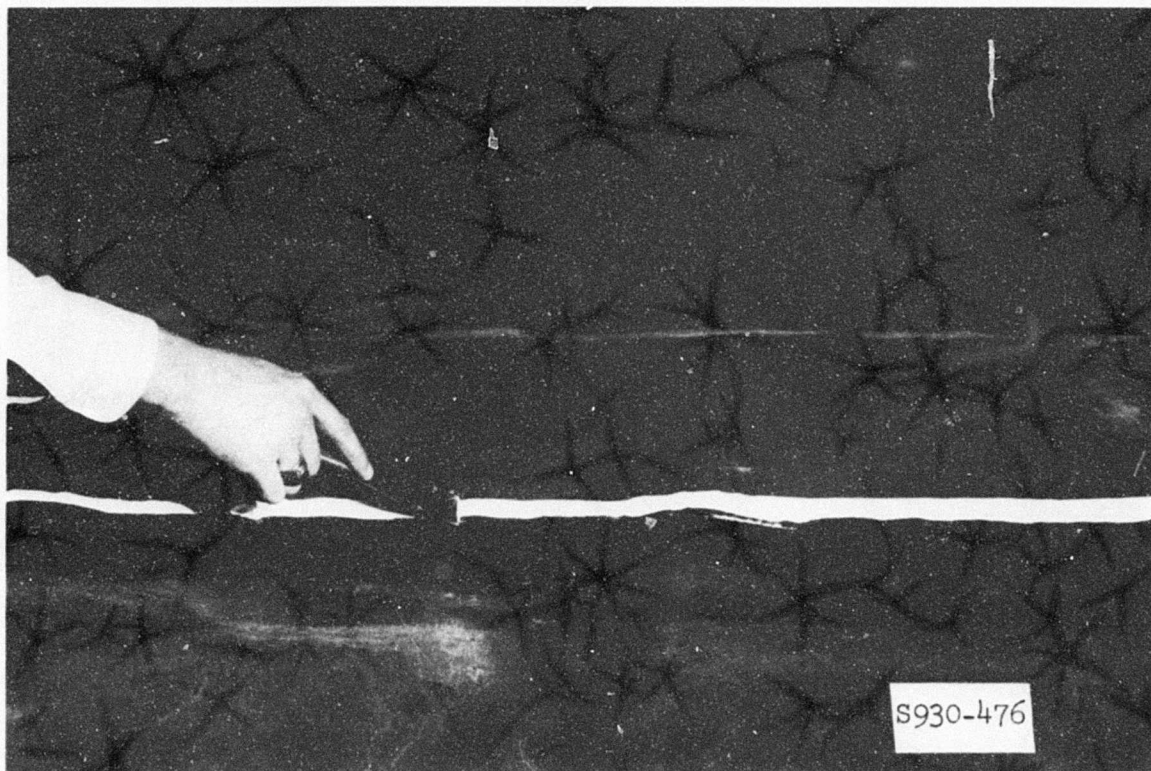
Photo 63. Beveling bead of Weatherban 101 sealant with putty knife

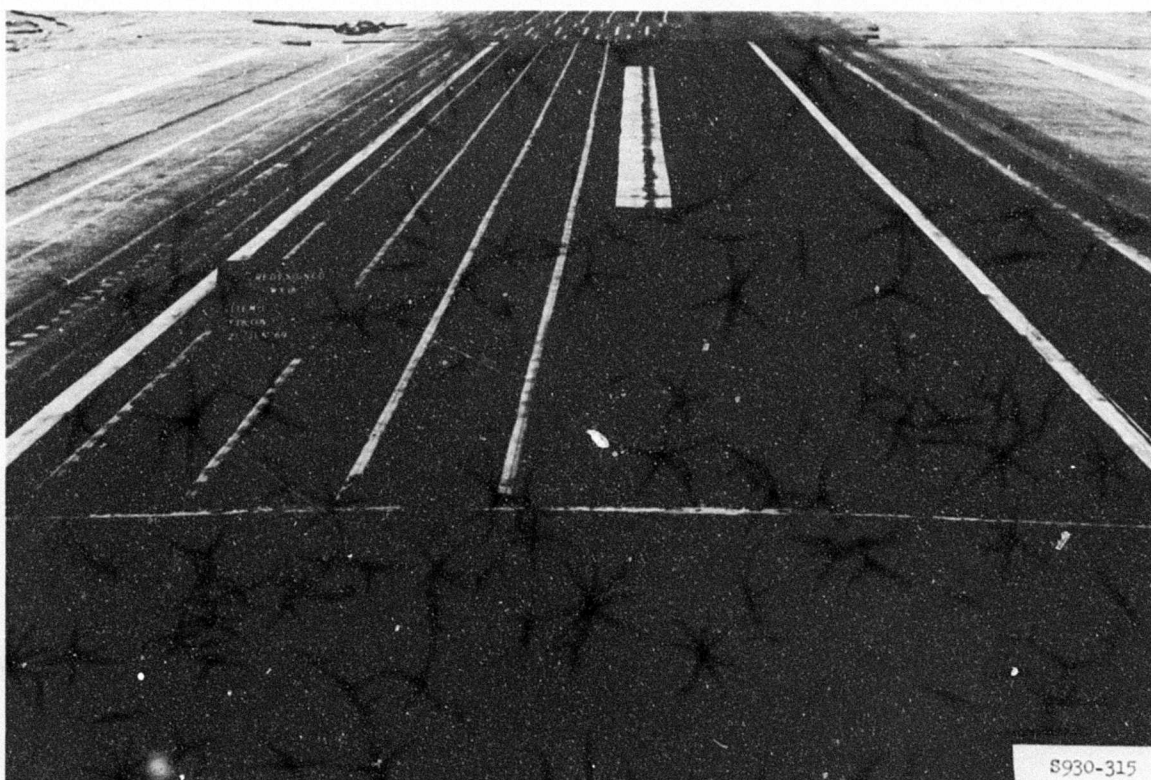
72. With the repair of the subgrade and replacement of sheet 3 completed, trafficking was resumed. At 738 coverages, no rutting of the subgrade was noted. The general condition of sheets 1, 2, and 3 at this time is shown in photos 64-66. The neoprene coating on one run of sheet 1 had worn down to the fabric. Photo 67 is a close-up of this condition showing the top ply of the fabric exposed in most areas except where the nonskid pattern remained. After 738 coverages, an inspection of the nonskid pattern on sheets 1 and 2 revealed that an average of 64 and 86 percent, respectively, of the nonskid remained. After 200 coverages, 84 percent of the nonskid pattern remained on sheet 3A (plate 17). The general condition of both sealants used along the edges of the reinforcing strips was good (photo 68). Both sealants exhibited adequate resistance to the wear of the test wheel, adhered well to the membrane, and provided watertight seals.

Photo 64. Sheet 1 of test section 1 after 738 coverages

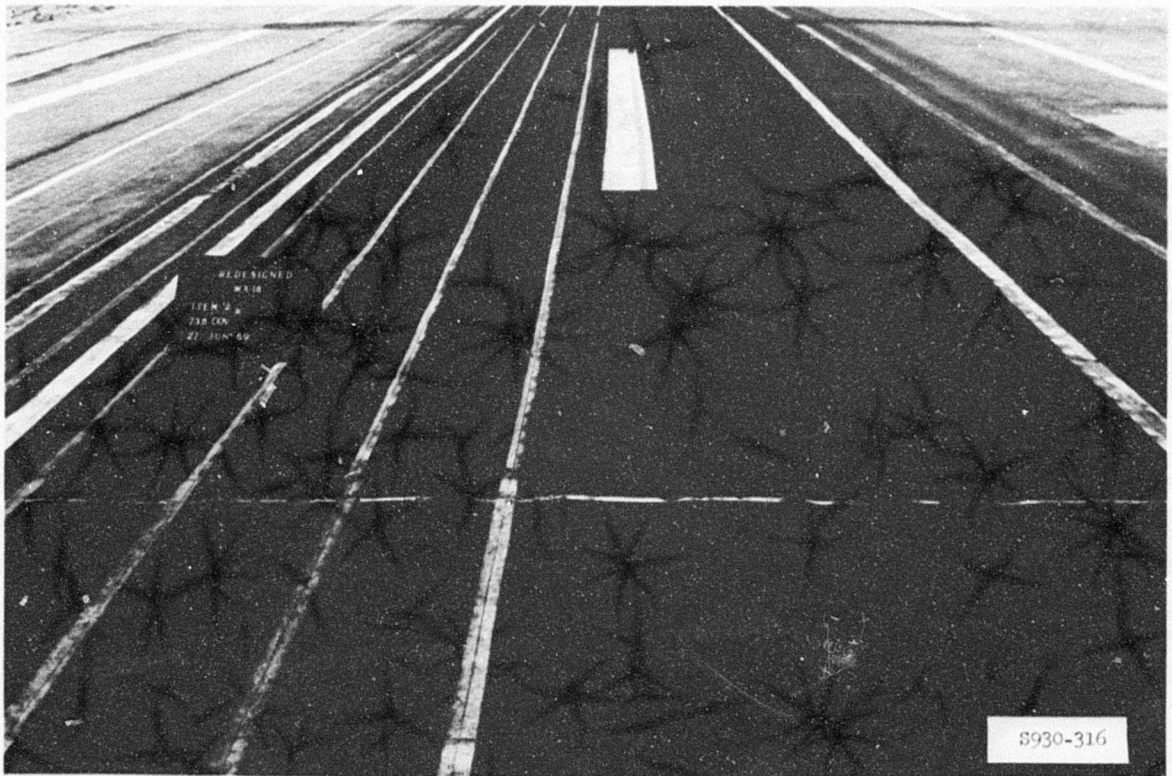
Photo 65. Sheet 2 of test section 1 after 738 coverages

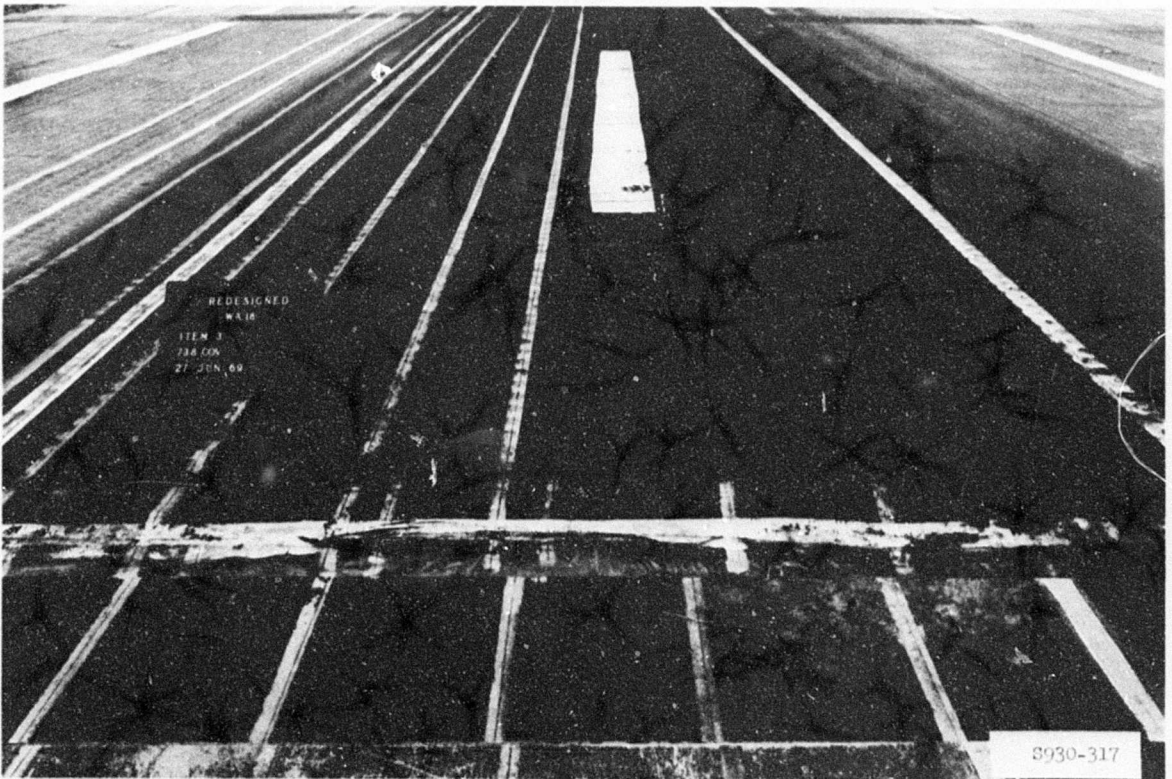
Photo 66. Sheet 3A of test section 1 after 200 coverages (total of 738 coverages on test section)

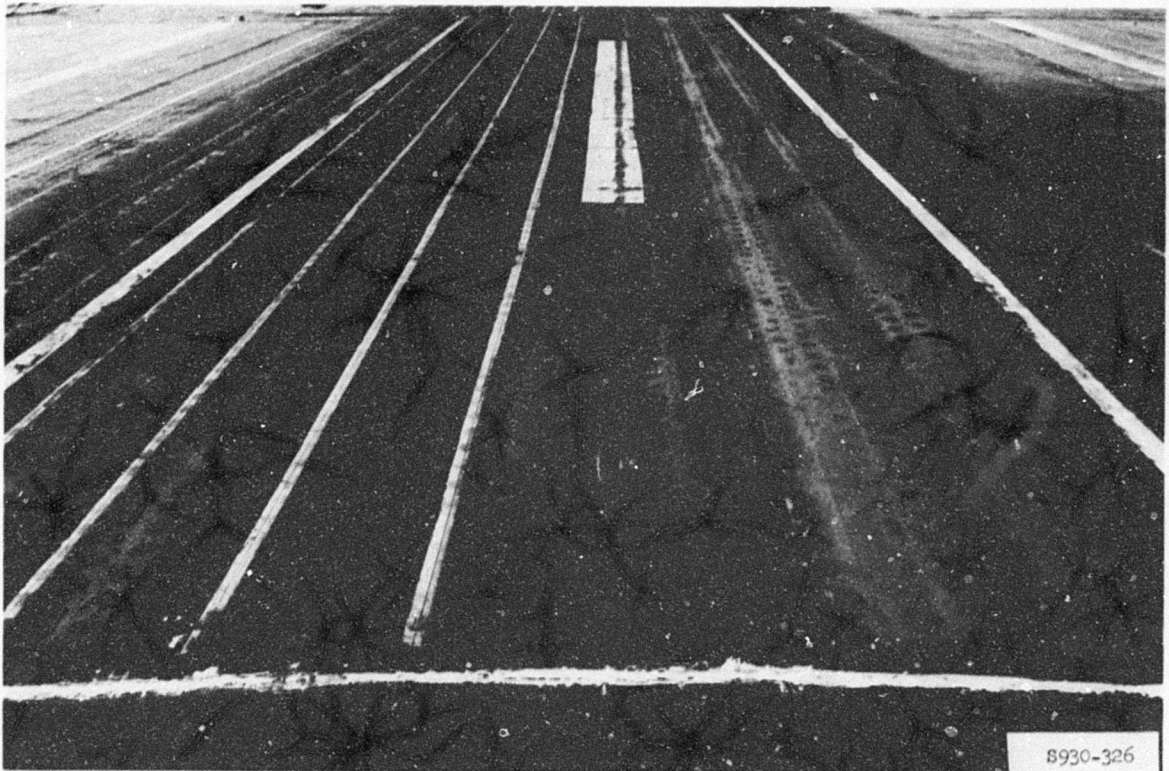
73. After 910 coverages, considerable wear had occurred on sheets 1 and 2, as shown in photos 69 and 70. The light areas in the traffic lane shown in the photos are areas where the neoprene coating was removed by the abrasion of the test wheel and the top ply of nylon fabric was exposed. The 6-in.-wide factory fabrication joints, however, were still in good condition. No repairs were necessary, and the membrane remained weatherproof. Sheet 3A also exhibited signs of wear, but to a lesser degree than sheets 1 and 2 (photo 71). However, a total of only 372 coverages of the test wheel had been applied to sheet 3A since it had been placed when the subgrade was repaired after

Photo 69. Condition of membrane sheet 1 of test section 1 after 910 coverages

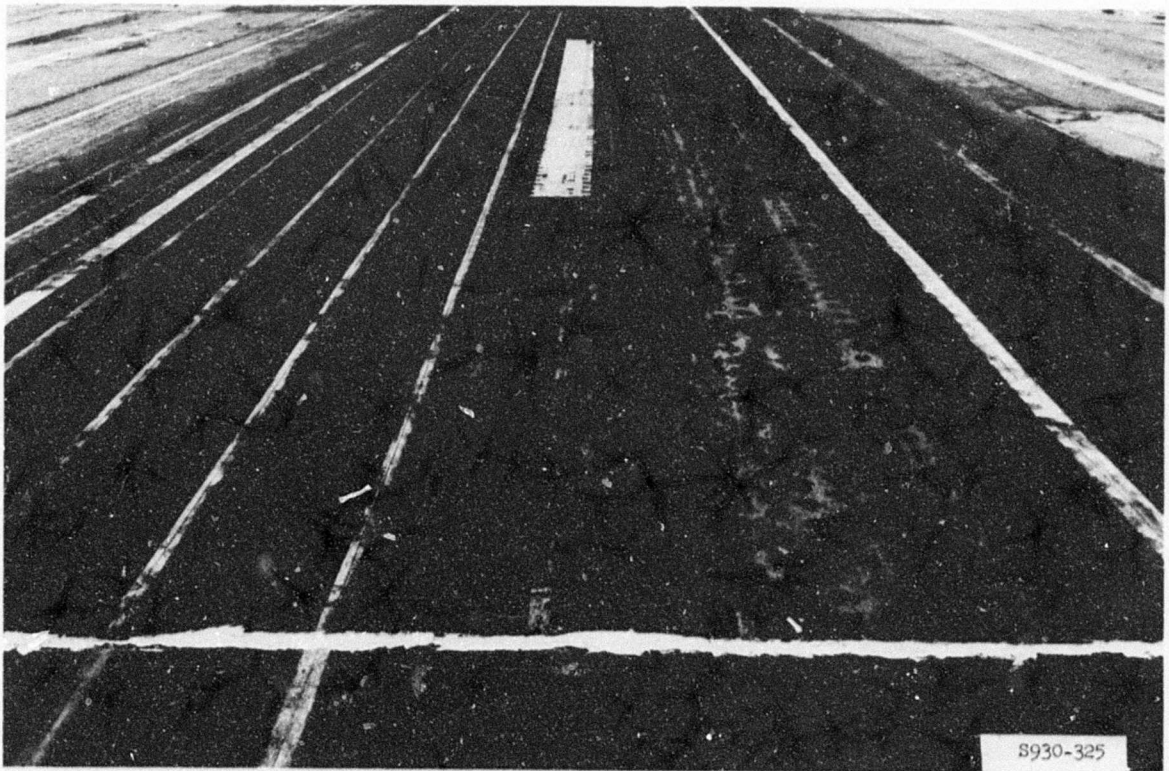
Photo 70. Condition of membrane sheet 2 of test section 1 after 910 coverages

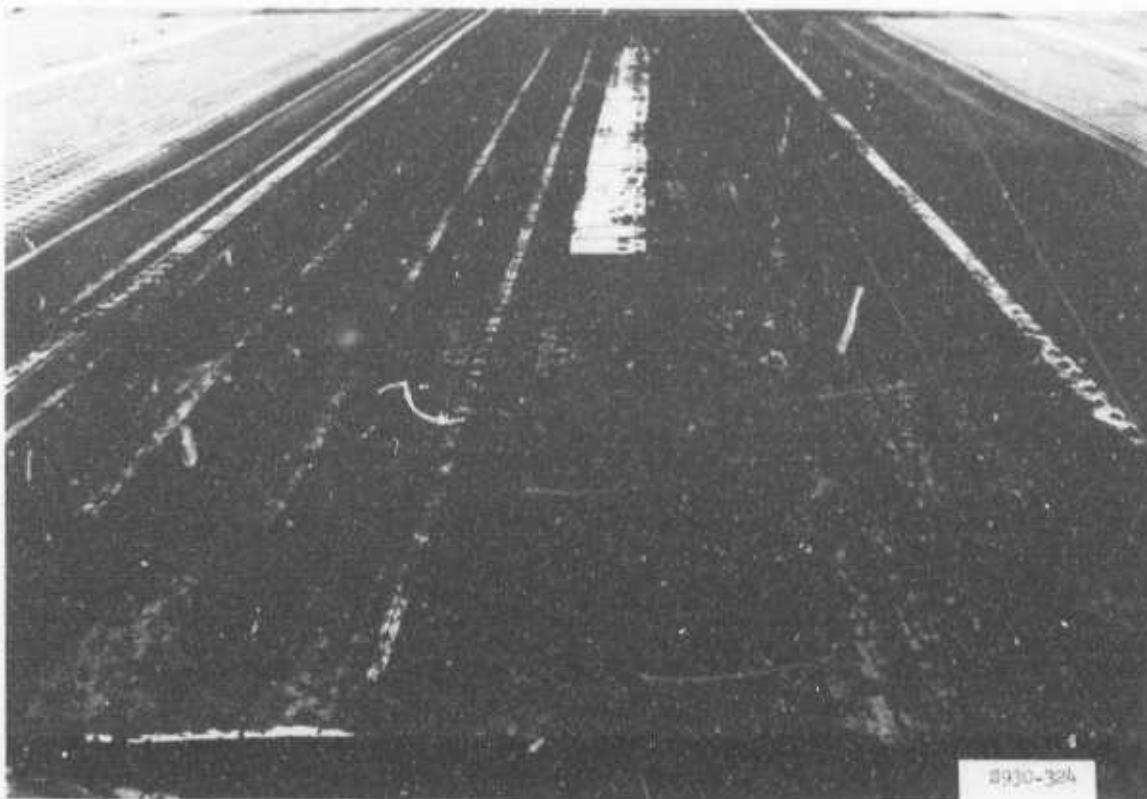
Photo 71. Condition of membrane sheet 3A of test section 1 after 372 coverages (total of 910 coverages on test section)

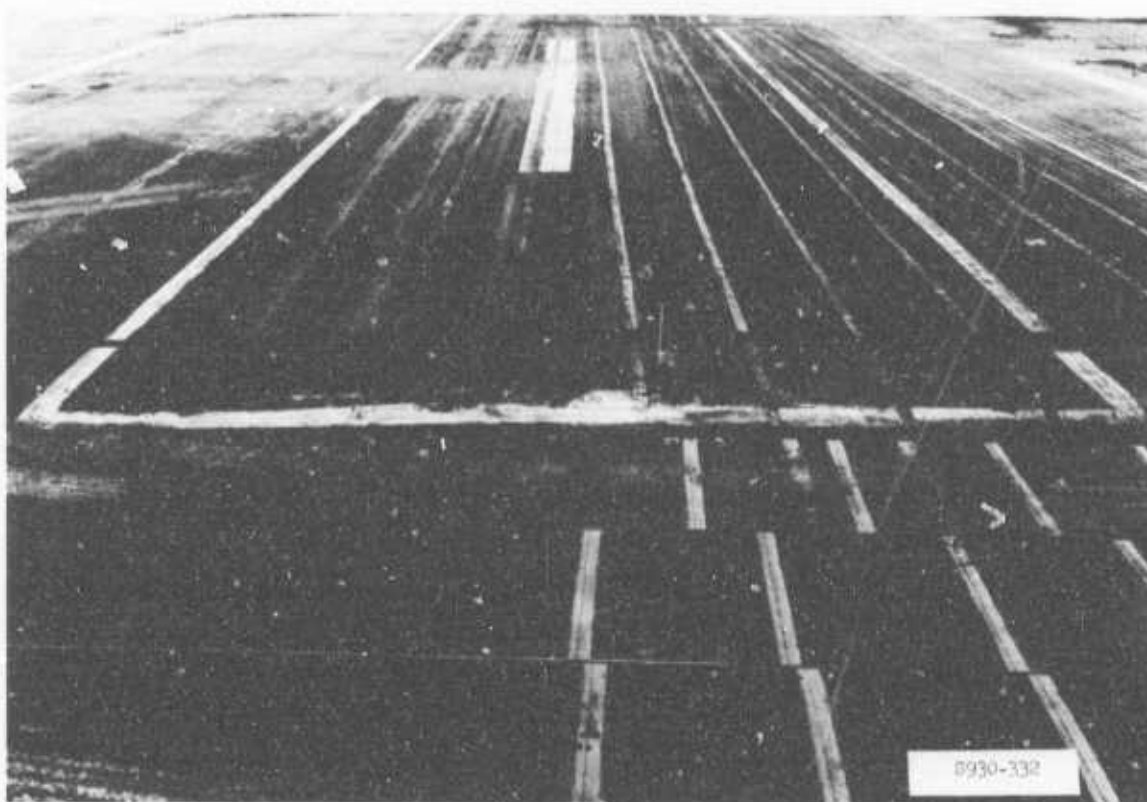
74. At 1200 coverages, the condition of the surfacing was generally unchanged. Photos 72-74 are general views of sheets 1, 2, and 3A, respectively. The patches shown on the membrane surfaces in the photos are areas where the membrane had been cut for CBR determinations. Severe wear of the neoprene coating on sheets 1 and 2 had been caused by the abrasion of the test wheel at this coverage level. Photos 75 and 76 show a close-up of the wear on sheets 1 and 2, respectively. Severe wear of the neoprene coating of this type was present on approximately half of the area of both sheets. Sheet 3A (photo 77), which had received a total of 662 coverages since it had been placed at 538 coverages, showed no degree of wear approaching that of sheets 1 and 2.

Photo 72. Condition of sheet 1 of test section 1 after 1200 coverages

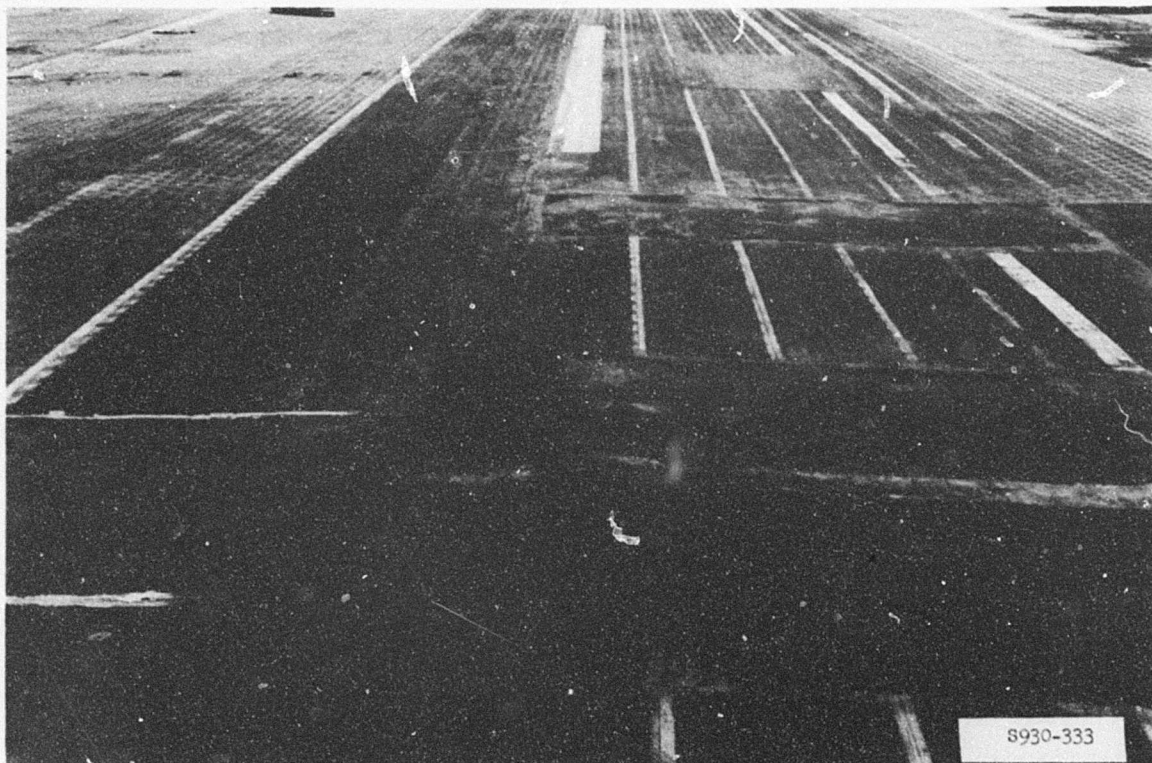
Photo 73. Condition of sheet 2 of test section 1 after 1200 coverages

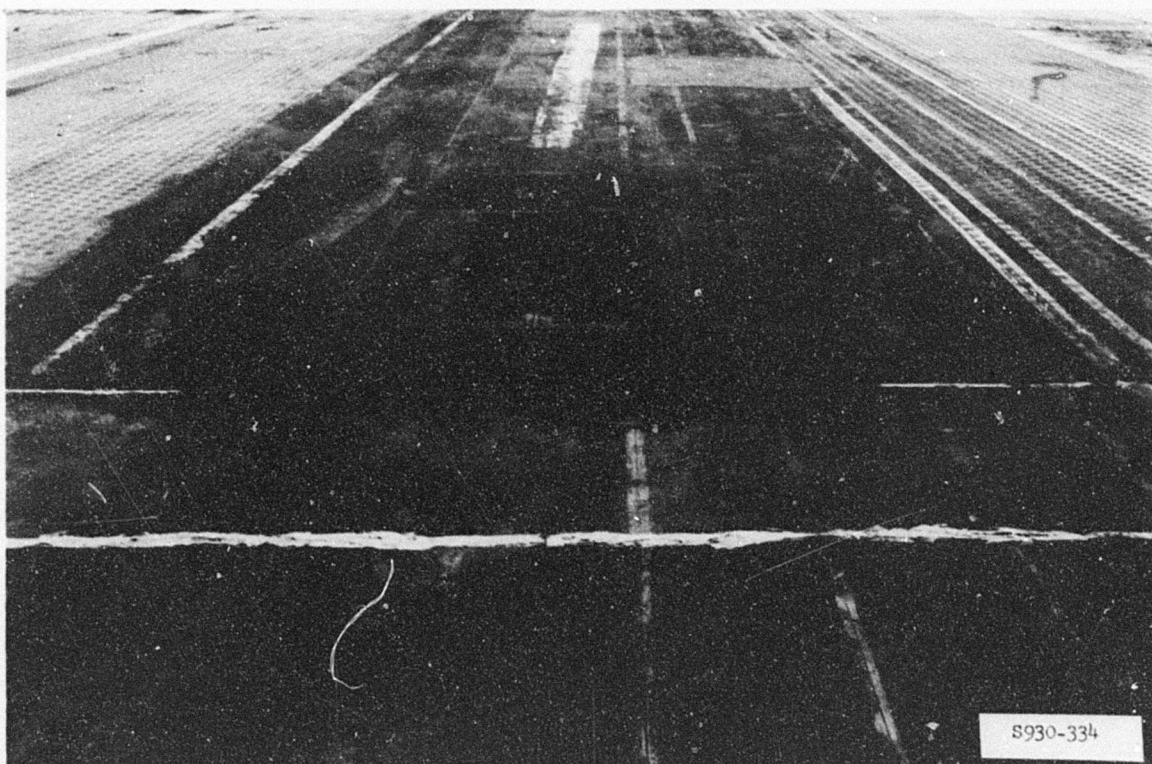
Photo 74. Condition of sheet 3A of test section 1 after 662 coverages
(total of 1200 coverages on test section)

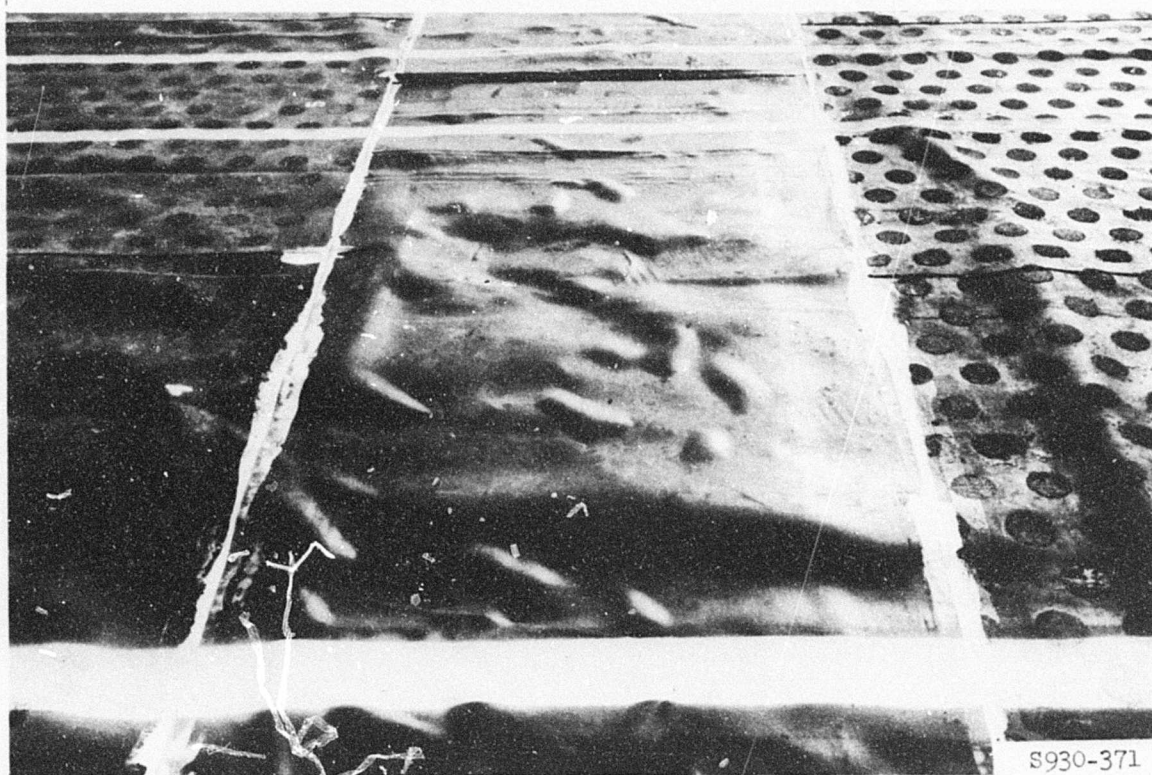
Photo 78. Condition of reinforcing strip and joint sealant prior to traffic on test section 2

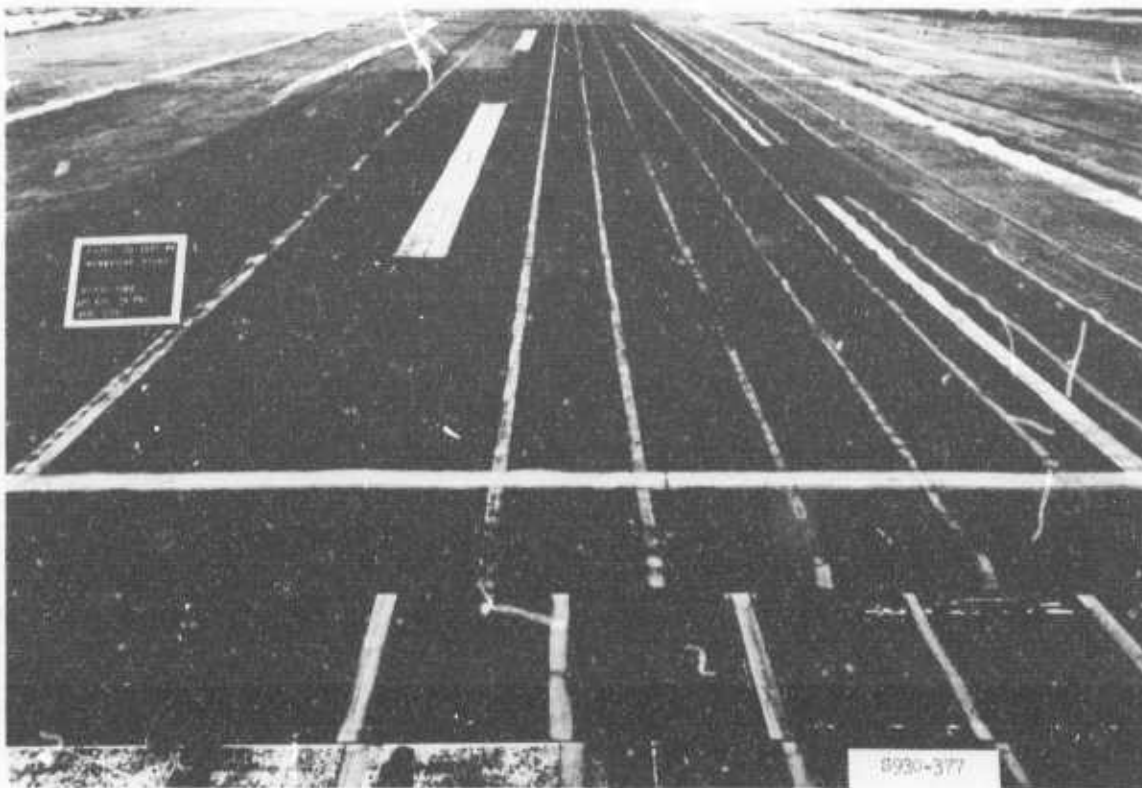
78. Photo 79 shows the general condition of the test section after 200 coverages. At this coverage level, there were no major occurrences, and the membrane showed little wear. Photo 80 shows the condition of the 3-ft-wide reinforcing strip on the joint between the two sheets. The sealant shown along the edges of the strip was wearing well and required no repair at this point. However, several of the 6-in.-wide factory fabrication joints that connected the runs of membrane were beginning to peel loose (photo 81). When the test wheel passed over a joint where a wrinkle resulting from slack in the surfacing was present, the wheel folded the wrinkle over, stressing the adhesive bond between the double layer of surfacing and causing the surfacing to peel loose. The peeled areas extended approximately 1 in. into the 6-in.-wide factory joints and were repaired by use of the MG-180 adhesive. Approximately 12 percent of the nonskid compound on sheet 1 and 5 percent of the nonskid material on sheet 2 had been removed by trafficking of the test vehicle at this coverage level (plate 19).

Photo 79. General condition of traffic test section 2 after 200 coverages
